# LAND INSTABILITY IN THE GENESEE RIVER VALLEY - LIVINGSTON COUNTY

### Subsidence and other events in the Boyd-Parker area<sup>2</sup>

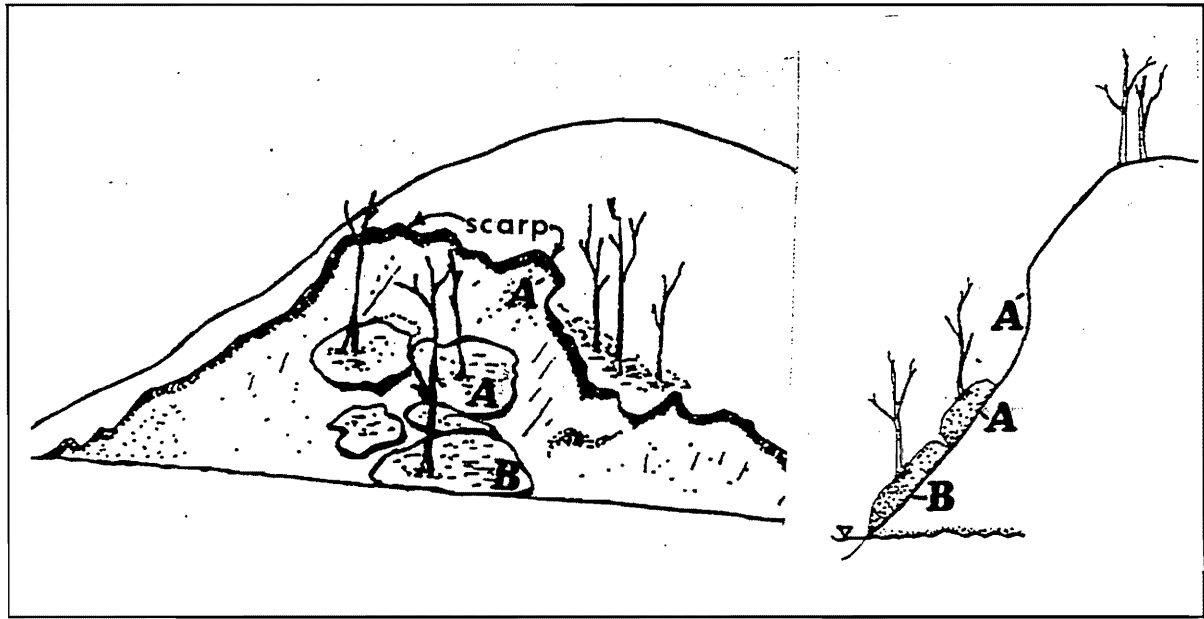
In 1988, when Wang made his first observations, multiple landslides were already evident (Figure 3). Figure 3 illustrates what we infer to be the initial stages in the destabilization processes affecting Irondequoit Bay slopes. The meter-high scarp surrounding the landslide complex reveals a meter-thick soil zone. Initial slope failure entailed the downslope movement of slabs the base of which is approximately the base of the soil zone. This slab carried with it all of the trees rooted in the soil zone. Even large oak trees have been transported down slope while initially remaining in upright position. Slab A began to move down slope in April 1990 to the position shown in April 1993.

This initial movement of the soil-zone slab effectively removes the protective cover from the slope, but it does not change the value of the slope angle. This process of block sliding takes place on differing scales as may be seen from the way in which the main scarp of this initial and largest landslides is itself cut by the scarps of several smaller landslides. Some of these smaller landslides are similar

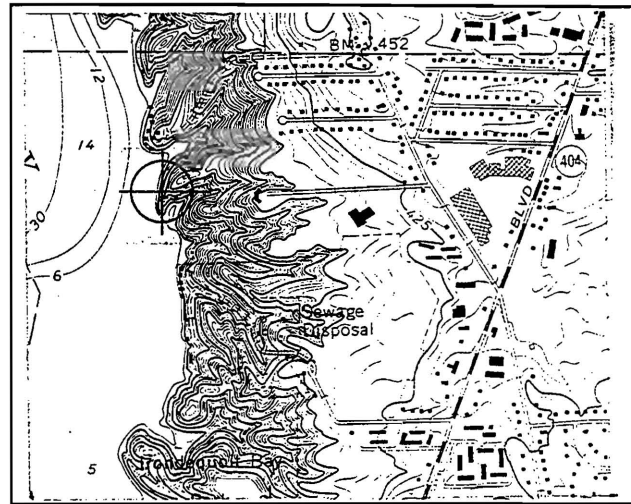
Figure 4 Stop 2 (Wang site SE-09-88)  
NYS 10 000 ft grid coordinates:  
783500E/1165200N

This site displays 3 bluffs (very steep unvegetated slopes), each of which is vertical in its upper part. The highest bluff rises 26 m (85 ft) above water level. The vertical upper face of these bluffs is created in a cohesive clay unit. Earth slump and earth flow of the non-cohesive materials that underlie this clay unit set the stage for the opening of vertical joints in the clay unit. Blocks of the clay unit as large as 2 m on a side then fall from this free face, sometimes remaining intact and sometimes breaking into numerous small blocks.

Below the vertical face are fans of material that has fallen from above and then accumulated at the base. Some vegetation has taken root in this material. During the summer and fall of 1993 and the late spring of 1994, these aprons were being eroded by wave action, and this erosion and undercutting of the base was triggering earth slumps 2.5 to 3.6 m (8 to 12 ft) high at the base of the bluffs. Earth flow is also common in the fans. Most of the steps in the process can be observed in real time whenever waves and boat wakes break along the base of this bluff.

These 3 bluffs first appear in the 1961 aerial photographs; they cannot be recognized in older photographs. They are interpreted as the end product of landslide processes that first operated on steep but vegetated slopes. Remnants of these slopes are still present. Complete removal of the original soil blanket and the vegetation rooted in that blanket set the stage for the operation of slump

processes. Undercutting by wave action during periods of high lake level (as in 1973 and 1993) removed the protective aprons, cut a shelf under the vertical bluff, and set the stage for earth topple noted above.

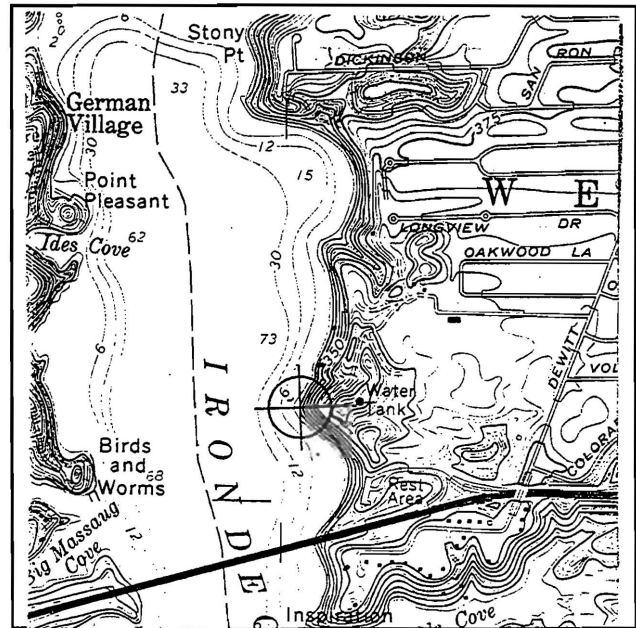
**Figure 5** Stop 3 (Wang's site NE-05-88).  
NYS 10 000 ft grid coordinates:  
780200E/1173700N

This slope displays at least 6 different landslide scarps ranging in age from 1930 (or older) to 1994. The oldest scarp (top at 33 m - 110 ft) above water level outlines a landslide area (probable earth block slide) visible on the 1930 aerial photograph. The entire slope within this oldest scarp displays none of the large trees that are uniformly present in the area outside of the scarp line. There were few large trees on this slope even in 1930. The upper part of this oldest landslide is covered by grass, bushes, and by a few trees less than 15 cm (6 in) in diameter.

All of the other scarps lying within the slope area bounded by the oldest scarp are displayed at lower elevations ranging from 8 m to 33 m (27 ft to 108 ft) above water level. Each scarp bounds a separate landslide, some of which are earth slumps. The youngest of these landslides, re-activated in 1993 when lake level was at a 20-year high, illustrates the conversion of a steeply sloping landslide site to an earth slump and vertical bluff.

The earth slump displayed in the lowermost 15 m (50 ft) of this slope began to form prior to 1978. It exposes an excellent sample of the type of section generally seen north of the Route 104 bridge. A clay layer at the base of the slope is overlain by at least 6 m (20 ft) of sand and silt displaying the climbing ripples characteristic of all northern sections. The upper edge of the scarp of this slump was at 15 m (50 ft) above lake level in May 1994. The upper 2 m of section display clay and silt layers with prominent pillow structures.

The inferred history of this site is as follows: (1-pre 1930) Undercutting at the base; large-scale earth-block sliding of blocks made up of the soil horizons. There were few trees left on this slope after this event. (2) Removal of tree cover, followed by episodes of high lake level led to the inception of the processes active in 1993-1994. (3) Undercutting of the base of the slope by wave action during periods of high water level. Major periods of high water level occurred in 1952, 1973, and 1993. (4) Failure by earth slumping, flow, and topple. These three types of landslide activity occur in conjunction with one another as illustrated by relationships expected to be visible in October 1994.

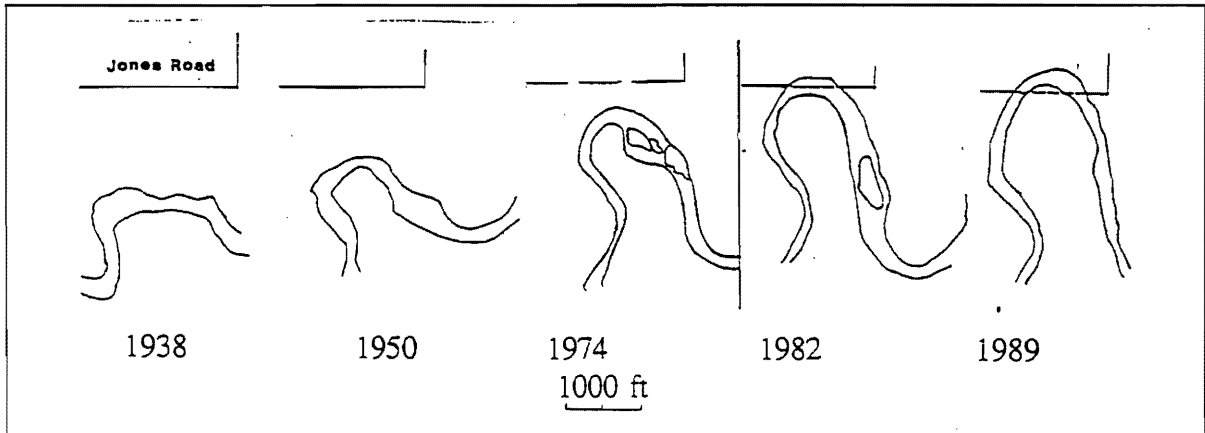
**Figure 7** Map of Christiano meander (MS-3) position 1938 - 1989. Plotted from aerial photographs by BOCES summer students 1989.

A prominent set of meanders at the southern edge of the Geneseo quadrangle has been migrating rapidly since 1938, cutting into an unpaved road sometime in the 1950s and progressively removing farmland from cultivation. The main meander here, informally designated as the Christiano meander (see figure 7 with road log), illustrates the meander migration process very well. The actual physical process very much resembles the failure process seen at Stop 2 at Irondequoit Bay in the Monroe County segment of this trip. This process and the results are described in the road log below.

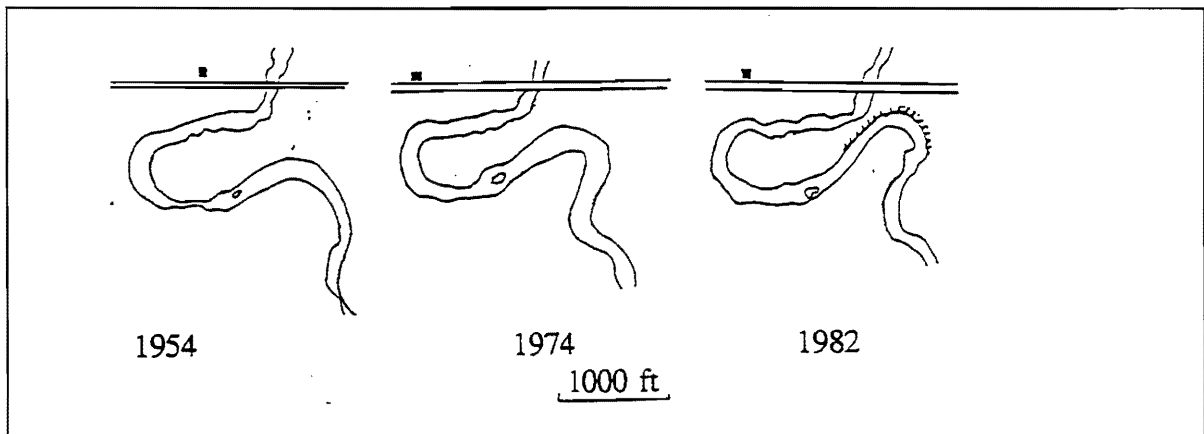
**Figure 8** Map of Route 20A (MS-1) meander 1954-1982. Compiled from aerial photographs by BOCES summer students 1989.

Meander activity at two locations south of Route 20A has been of substantial concern. Meander migration immediately south of Route 20A (see figure 6 and 8 with road log) threatened the bridge over the highway and the highway itself. Therefore the U.S. Army Corps of Engineers controlled this migration by placing rip-rap on the concave bank of this meander. As is evident from the map, this meander is also very close to cutoff .

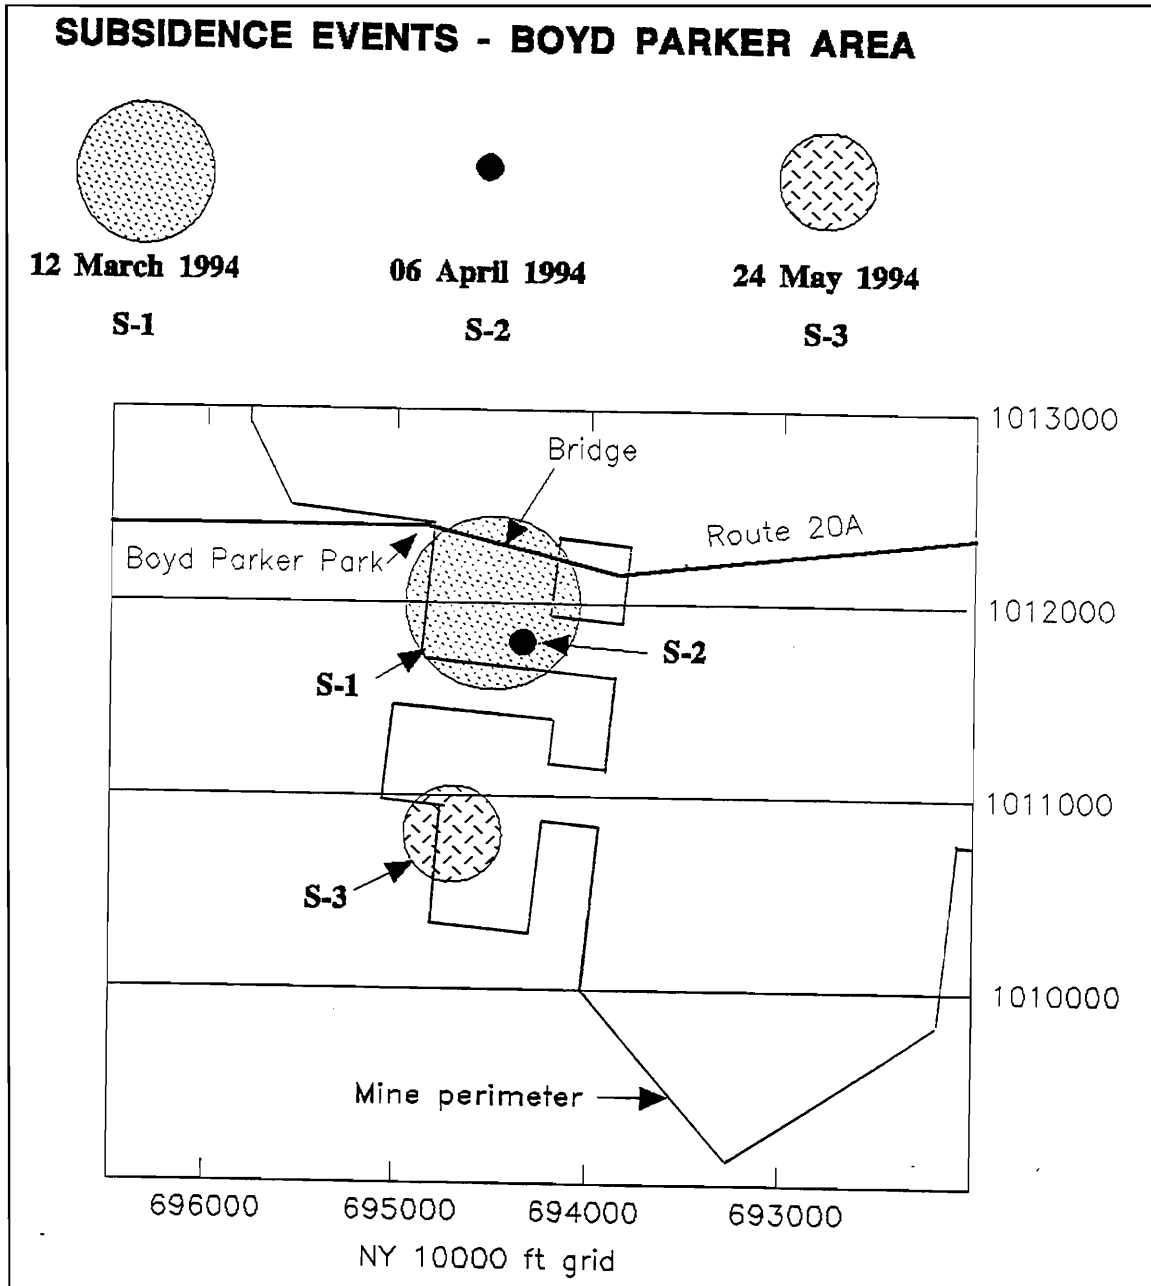
**Figure 9** Approximate locations of subsidence features and mine perimeter. Subsidence features based on field mapping. Mine perimeter from map provided by Akzo Salt, Inc. All boundaries schematic.

It was soon learned that changes had occurred below ground. These included the collapse of pillars previously supporting the mine roof, failure of the roof, and inflow of water into the mine at an initial rate estimated at 4000 gal/min. The area in which subsidence has taken place is referred to here as the Boyd-Parker area after the park located close to the center of the area. The initial subsidence area is designated as S-1 on the map accompanying the road log (Figure 9).

an approximately 4000 square foot area on the south side of Route 20A. This subsidence, estimated to be on the order of 10 ft (3 m) created a lake along this reach of Little Beard's Creek. This subsidence area is designated as S-2 on the map (Figure 9).

The gradual subsidence of area S-1 was punctuated by another event on 23 April 1994 when an open fissure having a circular plan formed around the outer edge of S-1. Then on 25 May 1994, yet another subsidence event occurred in the area designated as S-3 (Figure 9). This event was manifested by the formation of a sinkhole 600 ft in diameter and 70 ft deep in the center.

The map accompanying the road log (Figure 9) illustrates that subsidence area S-1 lies directly above a rectangular section of the salt mine set off from the main mine area at its southern end. In this section, the salt pillars left to support the roof were approximately 20 ft on a side. This is in contrast to the extensive mined area immediately to the north where the salt pillars were approximately 80 ft on a side. Subsidence area S-3 also lies above a rectangular section of the mine in which the pillars were 20 ft on a side. The 2 mine sections in which pillars 20 ft x 20 ft were left are bordered on the west and south by unmined salt or by a continuous "wall" of salt. The map (figure 9) shows the dimensions of the partial walls of salt on the eastern side of these two areas. Since the seismic event recorded on 12 March 1994 has been attributed to the fall of a volume of roof rock approximately 12 ft x 600 ft x 600 ft, then the implication is that a number of 20 ft x 20 ft columns failed almost simultaneously in order to make the fall of such a large block of roof rock possible. Subsidence at the surface (S-1) was simultaneous with the seismic event, indicating the rapid propagation of fractures (faults) upwards from the mine 1000 ft below.

also is apparently located directly above a second area of the mine in which the 20 ft x 20 ft mining method was used. This subsidence event differed from that at S-1 in a significant respect. Whereas subsidence at S-1 has been relatively gradual, except for the occurrence of event S-2 within the S-1 area, subsidence at S-3 was instantaneous creating a "sinkhole" reported to be 70 ft deep in the center. This geometry has suggested to observers who do not have access to the site that unconsolidated materials may have been transported downwards in the phenomenon known as "piping."
