Shinnecock Flood Tidal Delta and
Coastal Stabilization Problems West
of Shinnecock Inlet

Larry McCormick

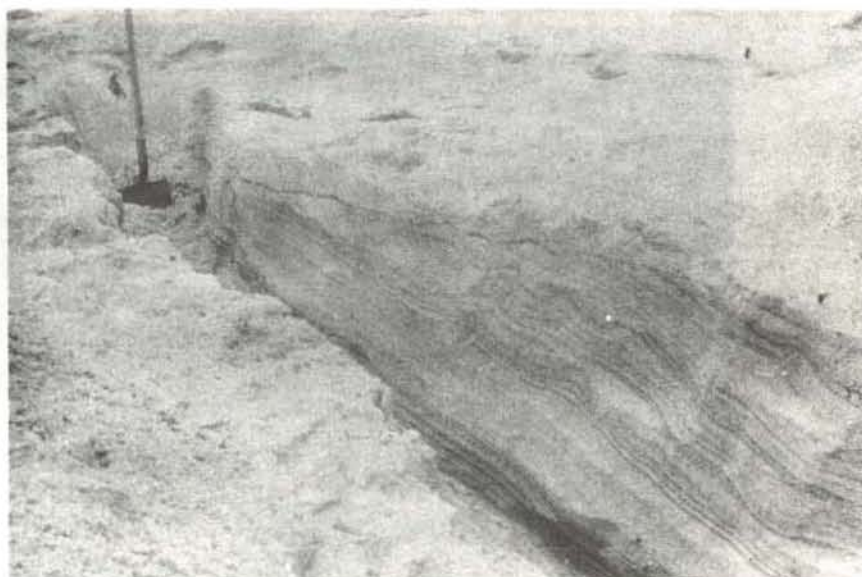
Berm wind lag layers cut by storm beach profile which is overlain by recent depositional packet of sand.

Thin heavy mineral layers (less than 2 inches) are common and frequently represent a wind lag deposit generated on the beach berm. In Plate 1B these berm layers have been truncated by a storm beach that has in its turn been buried by a wedge of light buff colored sand characteristic of rapid beach accretion.

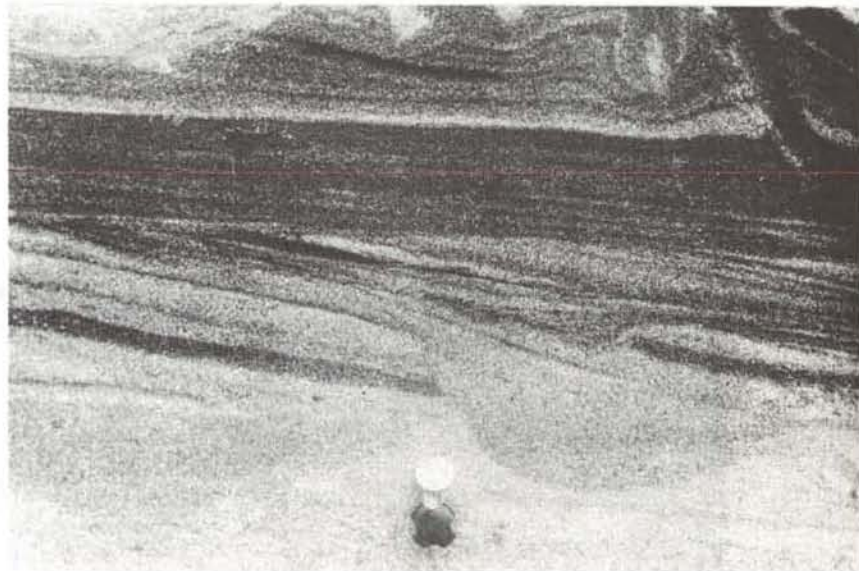
PLATE 2B

Close-up of scour and fill structure. Up beach is the right in photograph. Coin gives scale.

Heavy mineral storm layers may be simple lenses rich in garnet and magnetite or they can exhibit the rather complicated scour and fill structure illustrated in Plate 2A and B. The latter are produced as a wave cut scarp which migrates up the beach face under storm conditions. Waves strike the scarp and scour out a shallow trough carrying off the lighter minerals and leaving behind a thin apron of heavy minerals. As the scarp and trough migrate up the beach the thin aprons of heavies coalesce to form the thick upper heavy mineral layer.

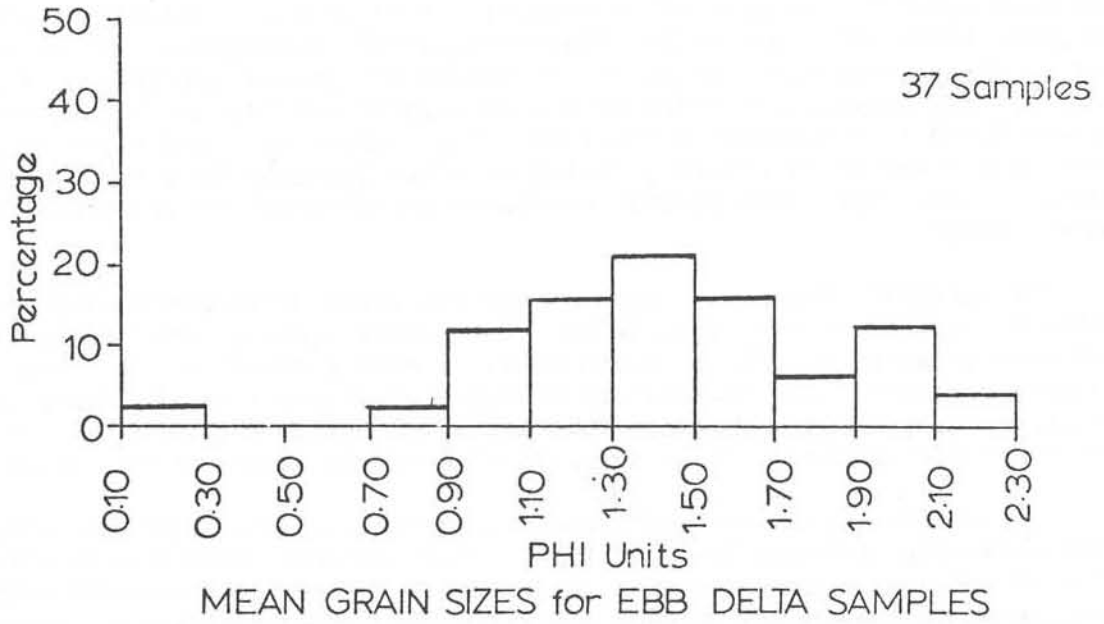
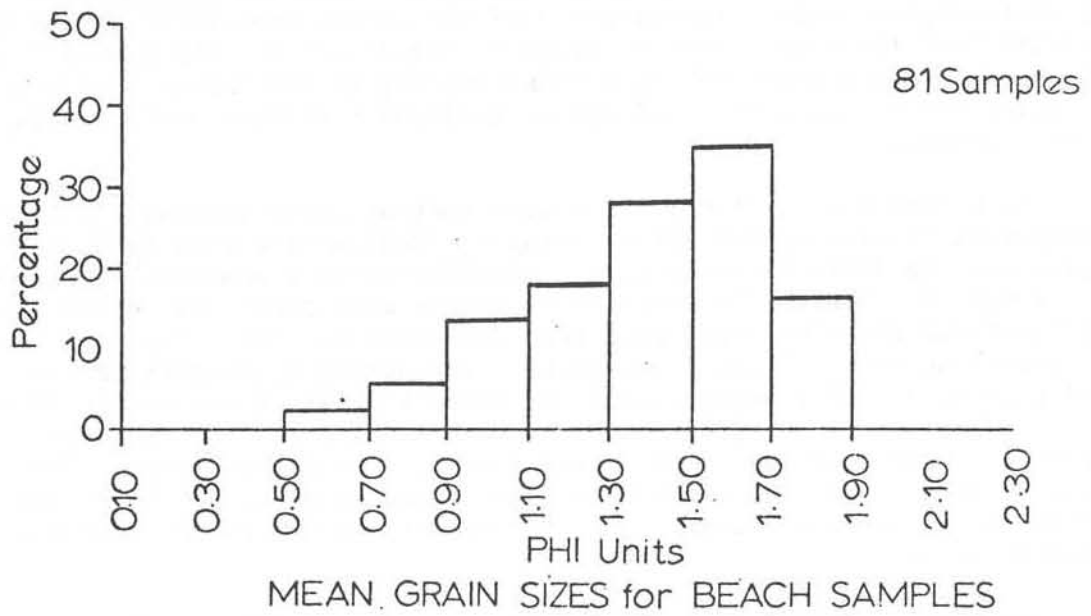
HISTOGRAMS of MEAN GRAIN SIZES for BEACH and EBB DELTA SAMPLES

The significance of this observation is that most of the material composing the delta is as coarse as material usually found on the beach and would be an excellent source of sand for beach nourishment programs. Figure 4 is a bar graph of the mean grain sizes of 81 samples taken at different times during 1970 and at locations scattered on the beach either side of the Inlet. The means that occur most commonly are in the range from 1.3 to 1.7 phi, very common sizes on the flood tidal delta.
